# MS-raft

**Multi-Sensors**

Partially Flooded Pipelines inspection raft

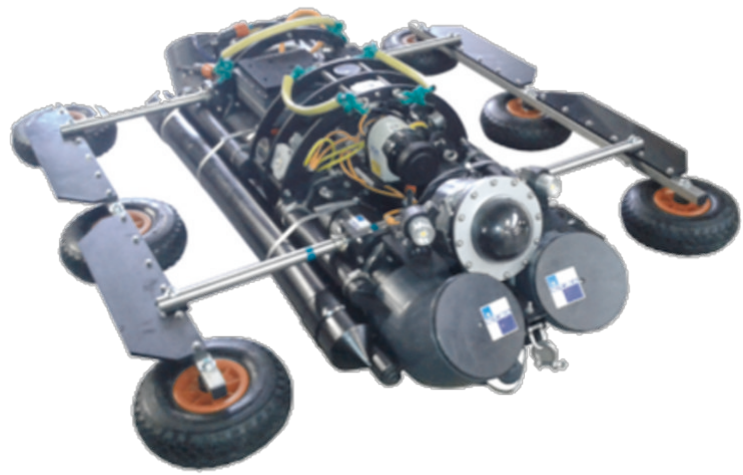
3off HD IP Cameras  
1off PTZ Camera  
1off Laser lidar  
1off Profiler sonar  
1off Inertial sensor  
5off LED spot lights  
1off Rim driven thruster
